MARINE CASUALTY REPORT

TANKSHIP PUERTO RICAN

EXPLOSION AND FIRE
IN THE PACIFIC OCEAN,
ON 31 OCTOBER 1984

MARINE BOARD OF INVESTIGATION REPORT

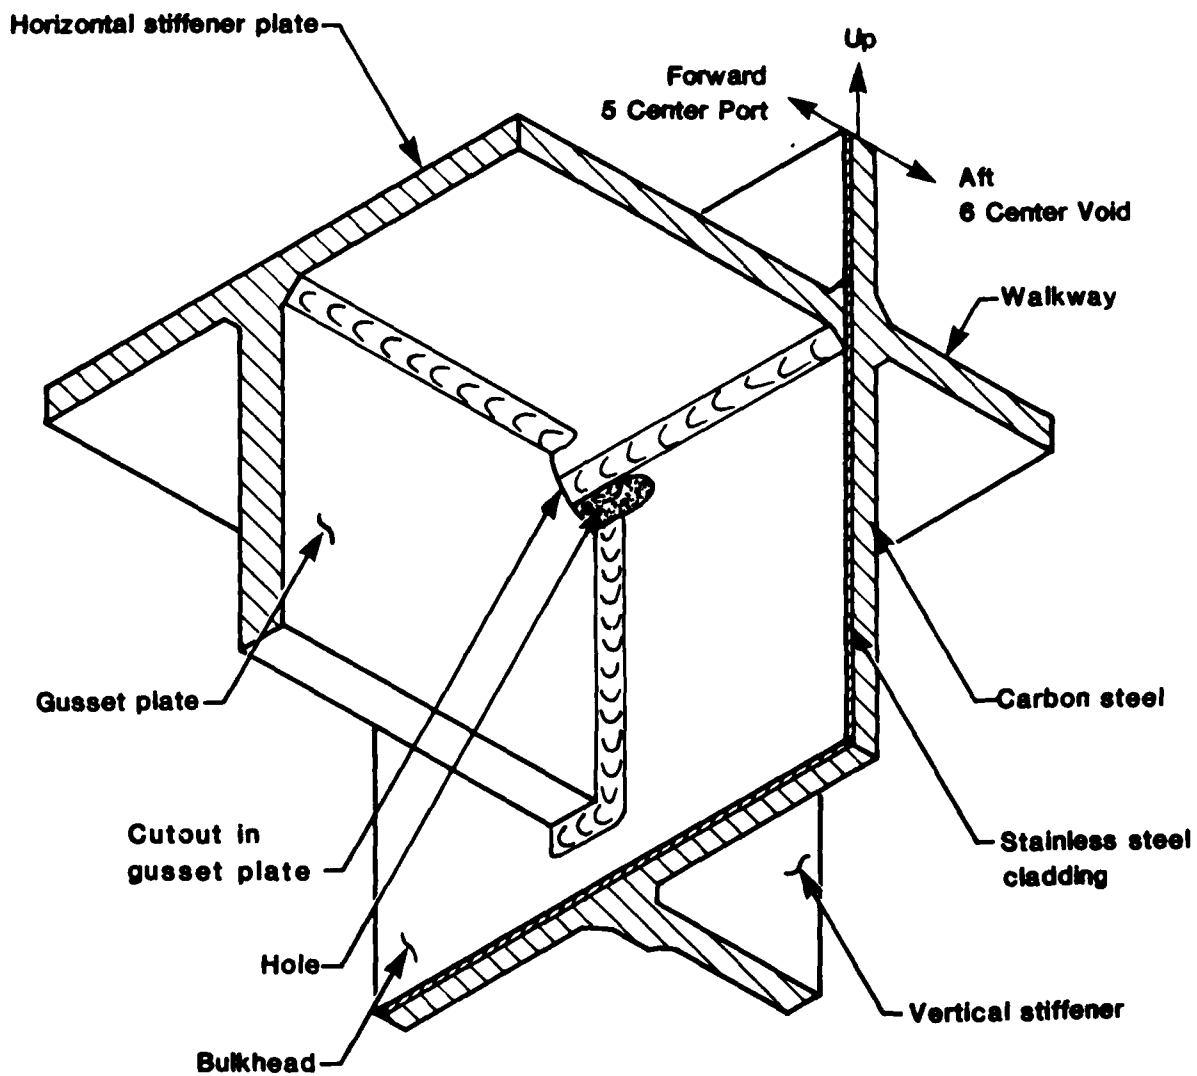
Figure 3. Sketch of hole in bulkhead between Tanks 5 Center Port (5CP) and 6 Center Void (6CV) for Case 1, seen from inside Tank 5CP below the hole.

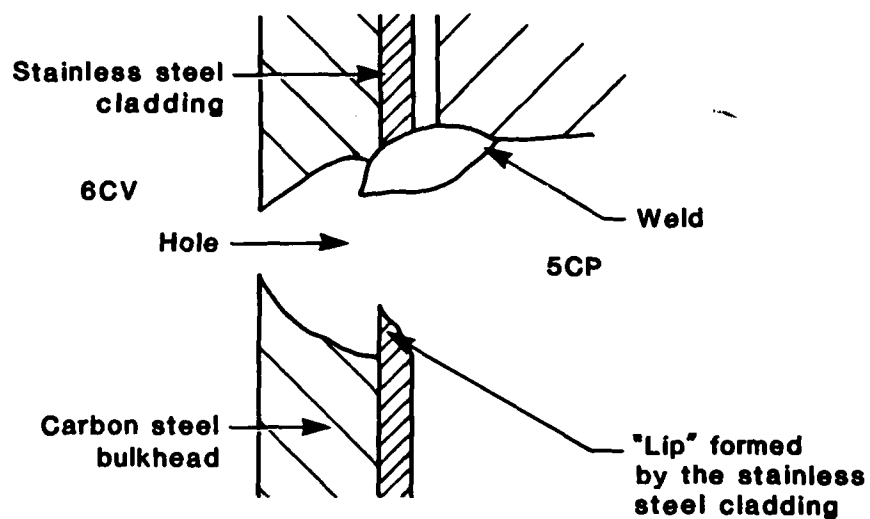
Figure 4. Schematic vertical cross section of the hole in the bulkhead between 6CV and 5CP.

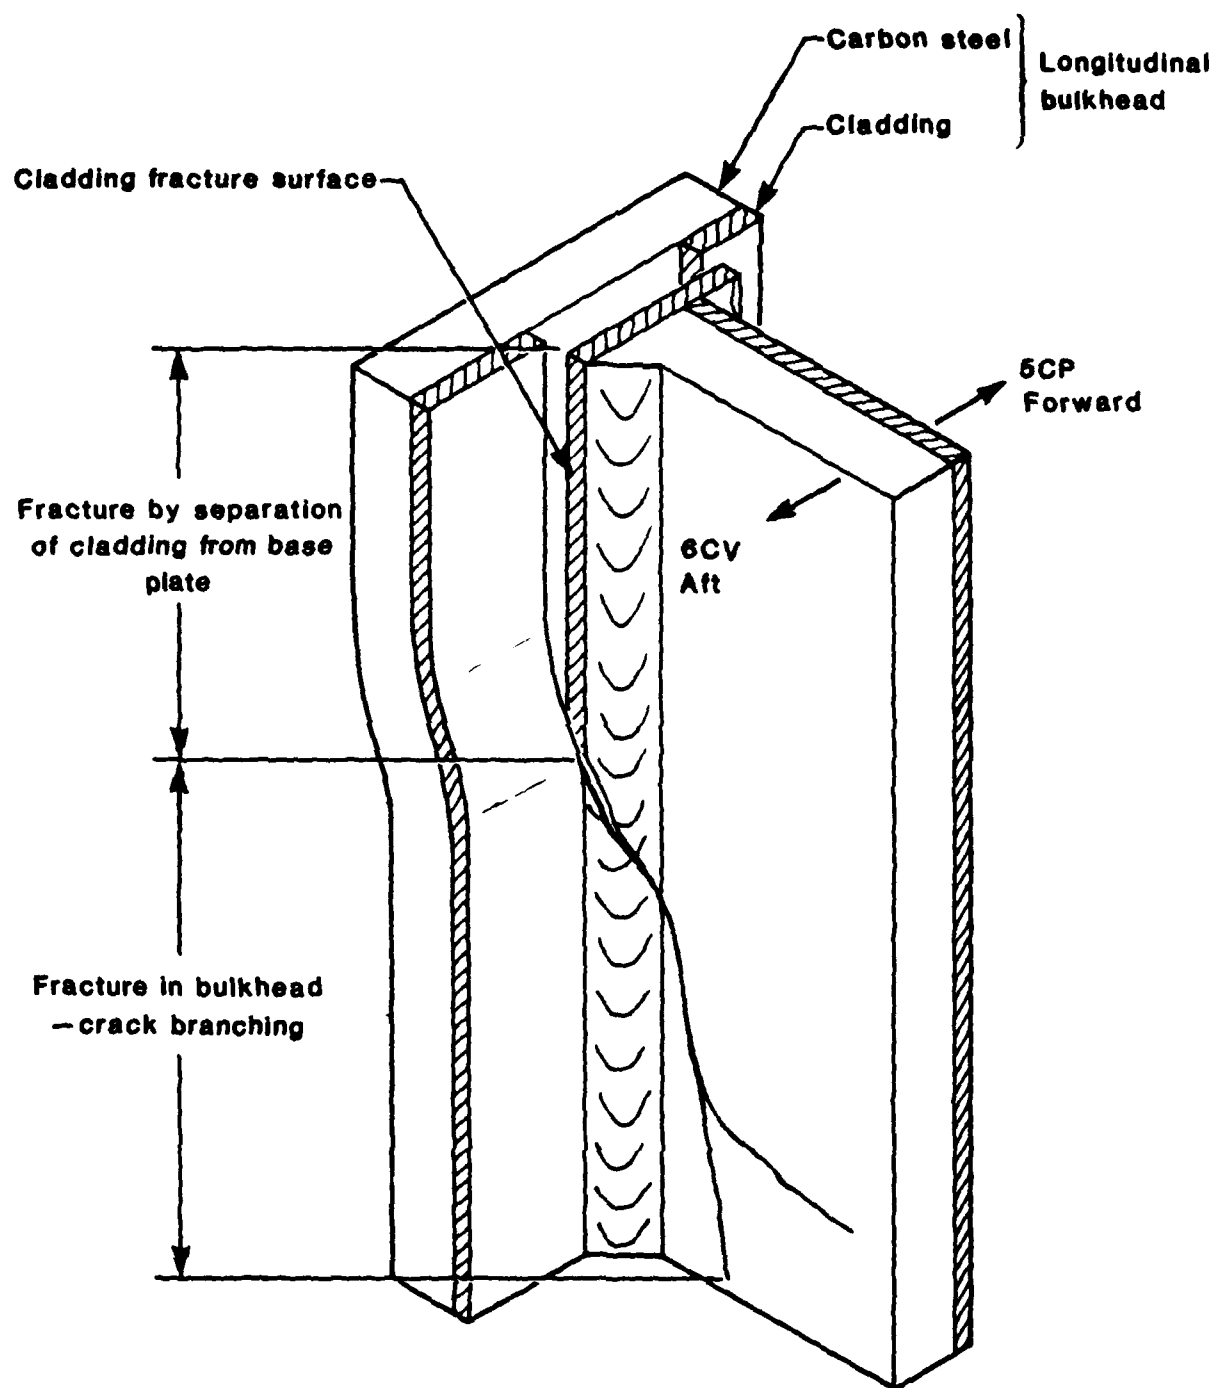
Figure 5. Sketch of different fracture paths in Cases 2 and 3.

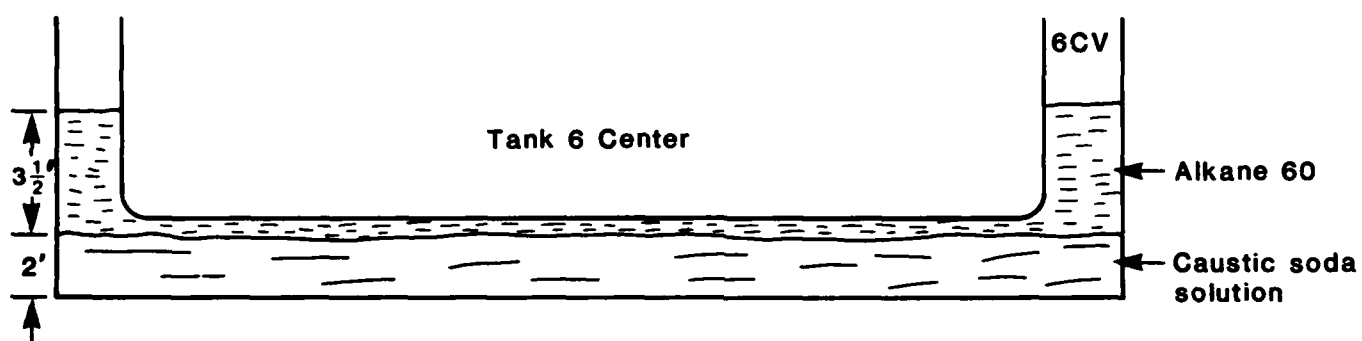
Figure 6. Schematic showing caustic soda solution and Alkane 60 in 6CV shortly before the casualty.
